12/13/2018

To: City of Boulder Open Space and Mountain Parks, Marianne Giolitto

From: Deb Hummel and Jessie Olson, Lefthand Watershed Oversight Group

RE: Monitoring to determine effectiveness of post-flood restoration on Left Hand Creek, Boulder County, Colorado

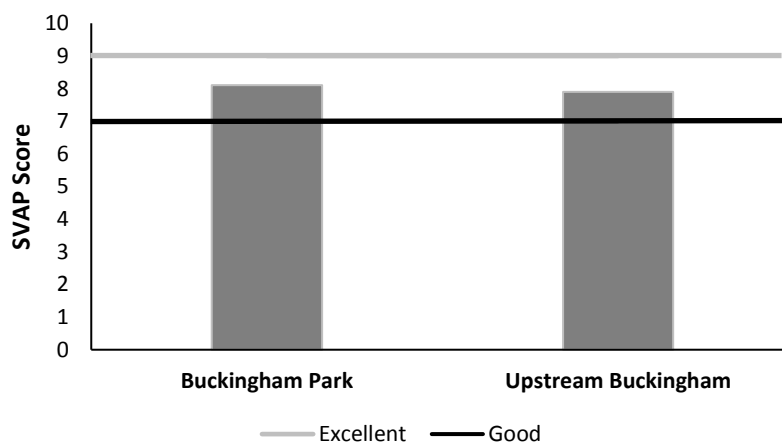
SVAP and LWOG site monitoring form observations provided an overall characterization of the study reaches. The SVAP score is an average of 16 geomorphic and biological elements individually scored from 0 to 10, 10 being the highest performing condition. The Buckingham Park control reach and Upstream Buckingham restored reach received similar SVAP scores of 8.1 and 7.9, respectively. Both values are within the good stream condition classification ranging from 7.0 to 8.9 (Figure 2). We hypothesized that restored sites would have less flood resilience one year after restoration compared to control sites. These results were in line with our expectation that the Upstream Buckingham site would have a lower overall SVAP score than the control site. Upstream Buckingham scored lower due to vegetation gaps, while Buckingham Park had greater cover and percentage of native species. The SVAP score was an important tool for preliminary reach-wide assessment, but further monitoring efforts were needed to identify and assess geomorphic and biological characteristics between reaches.

Figure 2. The 2018 overall SVAP scores for Buckingham Park and Upstream Buckingham reaches on Left Hand Creek, Boulder County, Colorado.

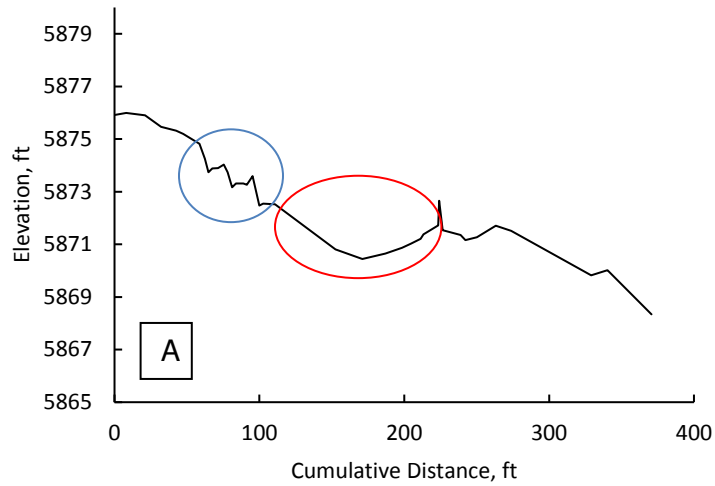
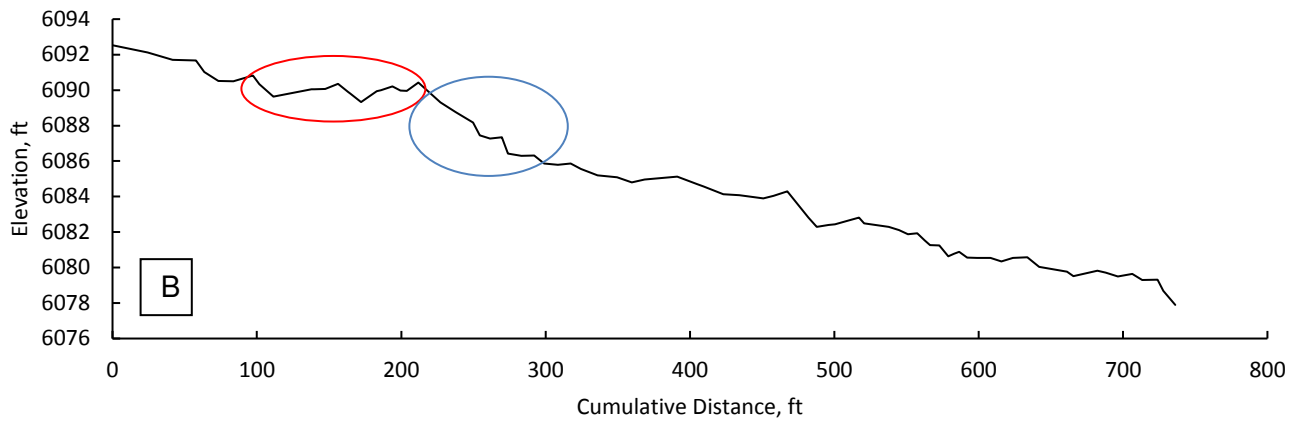
Both Buckingham and Upstream Buckingham reaches are characterized as canyon streams. Both sample reaches included a pool and riffle. A longitudinal profile was measured along the thalweg of each reach (Figure 3). The lengths of each profile were dependent on sampling equipment and satellite communication. The 375 ft. long profile for Buckingham Park illustrates a continuous riffle followed by a series of step pools and a 125 ft. long pool beginning at 100 ft. cumulative distance. The reach then continues with a continuous riffle. The 750 ft. long profile for Upstream Buckingham illustrates a riffle followed by a 100 ft. pool beginning at 100 ft. cumulative distance. The channel then follows a short step pool complex and a long continuous riffle. At 715 ft. cumulative distance, the long profile illustrates the crest of a second pool. Similarly, the maximum water depth at both pools were greater than 33 inches and deposition of fine sediment was observed.

Figure 3. The 2018 longitudinal profiles for A. Buckingham Park and B. Upstream Buckingham sample reaches on Left Hand Creek, Boulder County, CO. Red circle indicates a pool and blue circle indicates a step pool. Cumulative distance for Buckingham Park is abbreviated to scale.

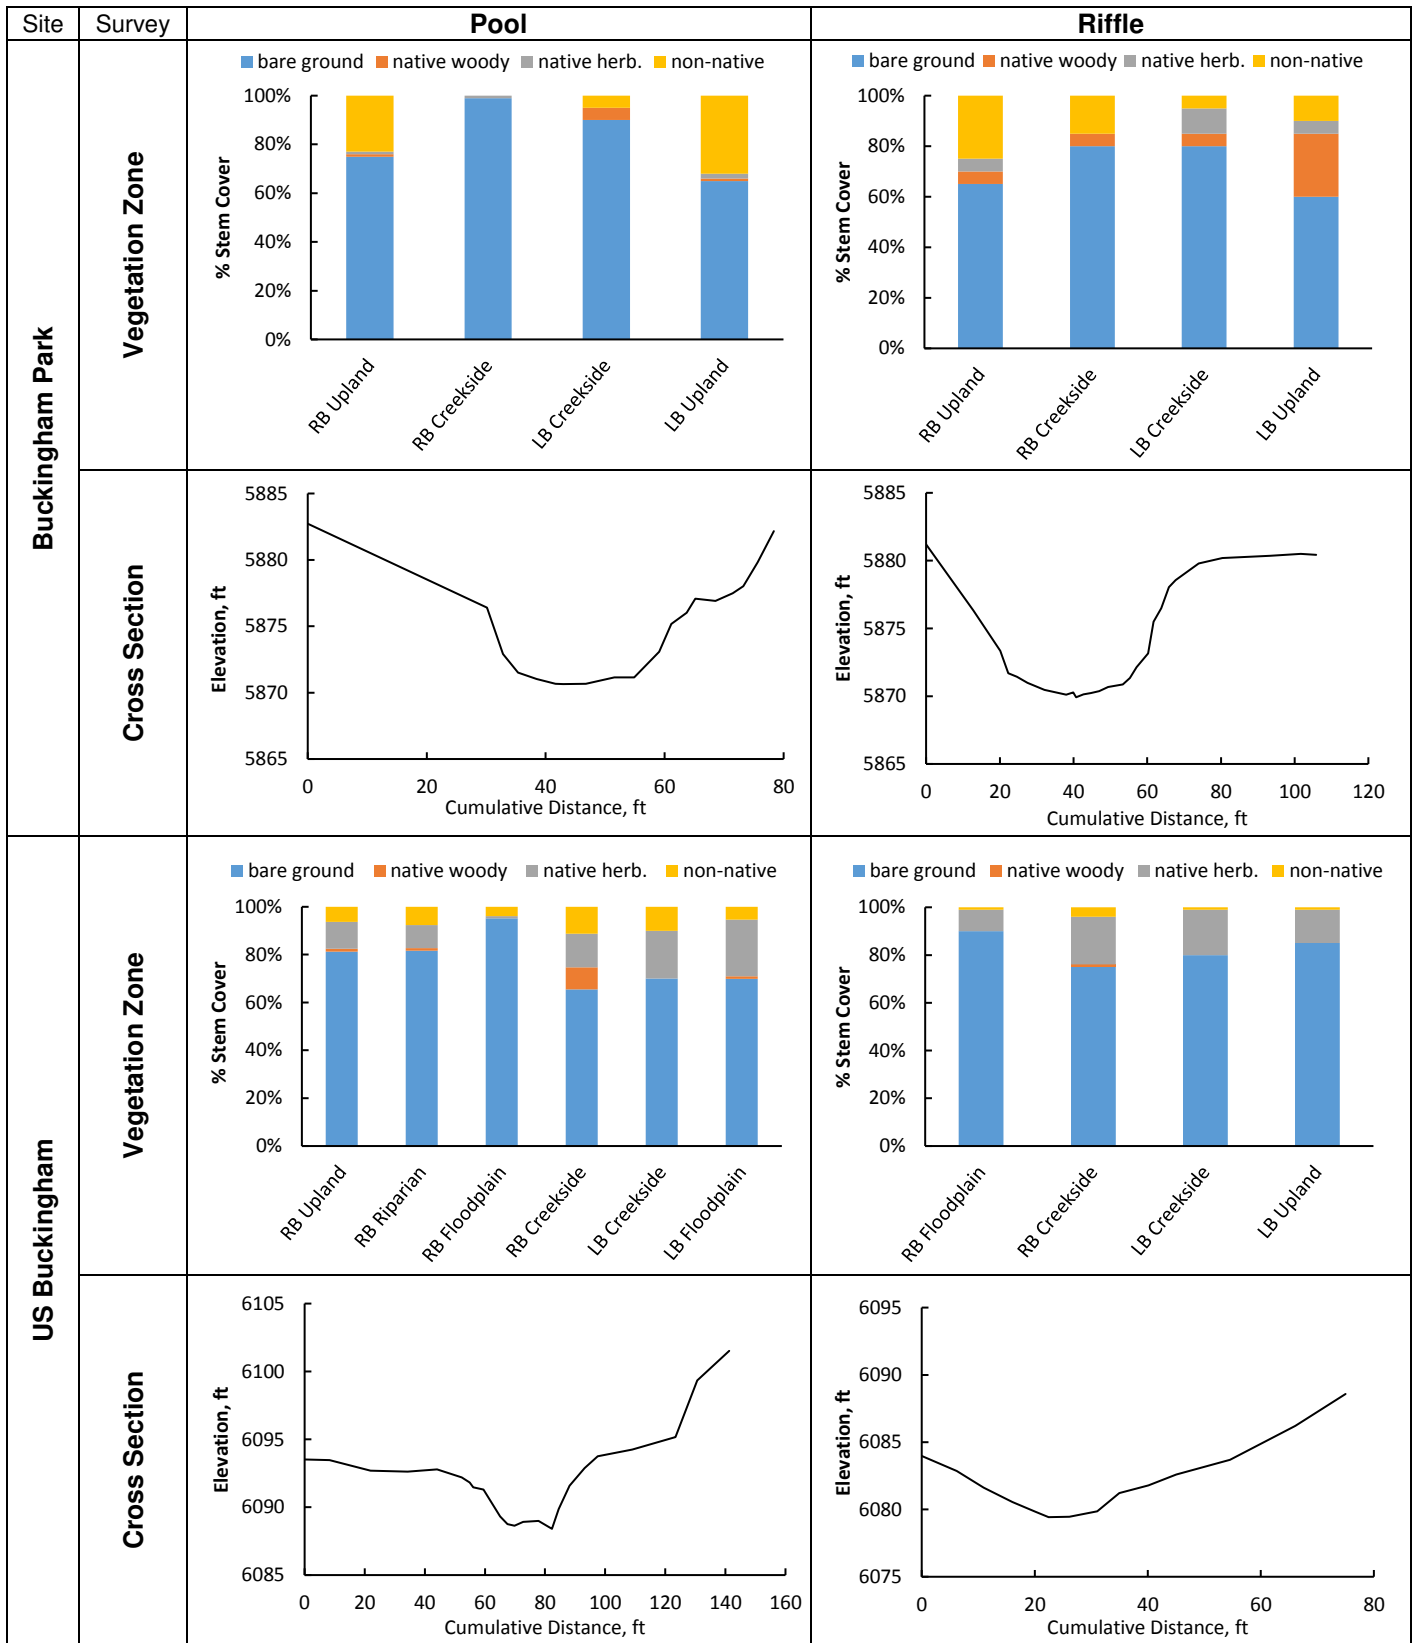
In addition, cross sectional profiles were surveyed at each pool and downstream riffle and were supplemented with pebble counts and vegetation surveys. Canyon streams are characterized by steep upland banks and these were observed at both sites. However, the channel at Buckingham Park is slightly incised due to additional constraints including Left Hand Canyon Drive and the park adjacent to the right bank (Figure 4). Upstream Buckingham reach is also constrained by Left Hand Canyon Drive on the left bank, but the channel has more access to its floodplain. Additionally, recent activation of the restored floodplain was indicated by rack lines and small wood accumulation. These comparisons and observations suggest that the restoration effort at Upstream Buckingham successfully reconnected the floodplain.

Revegetation throughout the riparian corridor after flood disturbance is critical for bank stabilization and ecological habitat. At a minimum, four vegetation zones were assigned per cross section, these included creekside and upland vegetation plots for each bank. Additional floodplain and upper riparian zones were identified and sampled at the discretion of the surveyors. We found that bare ground comprised 60% or more of vegetation zone plots for both sites (Figure 4). Overall, US Buckingham Park vegetation zones had a higher % stem cover of native herbaceous and woody plants. In contrast, Buckingham Park vegetation zones had higher % stem cover of invasive plants, with the exception of the left bank upland plot along the riffle transect.

Figure 4. The 2018 pool and riffle survey results for Buckingham Park and US Buckingham sample reaches on Left Hand Creek, Boulder County, Colorado. Composition of the vegetation zone (Upland, Riparian, Floodplain, or Creekside) is illustrated by % stem cover of bare ground, native woody, native herbaceous, and non-native plants. Banks are oriented as if the observer were looking downstream. Cross sections for each pool and riffle are plotted by elevation (ft) and cumulative distance (ft). Profiles are oriented as if the observer were looking upstream. Vegetation Zone charts and Cross Section graphs are directly correlated by cumulative distance, but rather rough estimates.

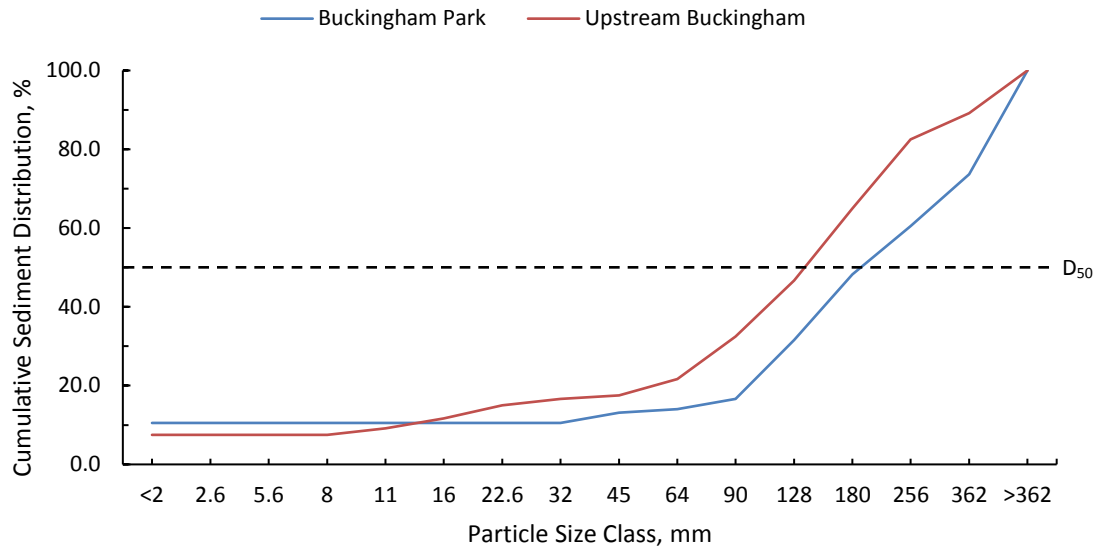
Sediment size and distribution further characterized bankfull substrate at the pool and riffle sites. Theoretically, the median cumulative 50% (D_{50}) sediment distribution corresponds with the substrate particle size (mm), and every particle size less than, that will mobilize at bankfull flushing rates without larger obstruction such as large boulders (Wolman 1954). At the riffle cross sections, the D_{50} particle size was 128 mm at Upstream Buckingham, while the D_{50} particle size at Buckingham Park was 180 mm (Figure 5). Overall, both sample reaches had similar substrate size distribution. The smaller median size at Upstream Buckingham is reflective of a higher relative frequency of cobbles (>64- 256mm), while Buckingham Park had a higher relative frequency of small boulders (>256 mm). In unrestored area, we would expect to have larger debris armoring banks at bankfull width, while restoration efforts may have reduced these larger substrate size classes. The riffle section of Upstream Buckingham may have had higher relative frequencies of smaller substrate compared to Buckingham Park due to restoration efforts.

Figure 5. The 2018 particle size class (mm) and cumulative sediment distribution (%) of substrate at the Buckingham Park and Upstream Buckingham riffle cross sections on Left Hand Creek, Boulder County, CO. D₅₀ dashed line indicates the particle size at which 50% of all samples were equal to or less than.

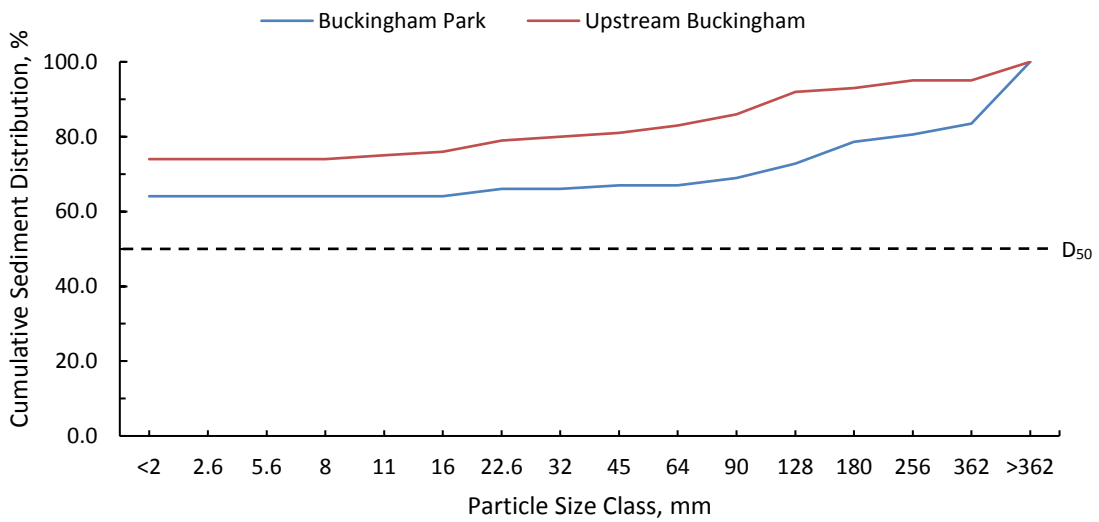
At the pool cross sections at both sites were similar in sediment distribution. Upstream Buckingham and Buckingham Park pools were composed of 74% and 66% sand (<2 mm), respectively (Figure 6). The pool at Upstream Buckingham is located on a river bend, while the pool at Buckingham Park is within a straight section of stream. Upstream Buckingham may have greater deposition due to slower velocities at the river bend. Lastly, since both pools were greater than 50% sand, it is likely that most of the sand deposition in these pools will mobilize at bankfull flushing rates.

Figure 6. The 2018 particle size class (mm) and cumulative sediment distribution (%) of substrate at the Buckingham Park and Upstream Buckingham pool cross sections on Left Hand Creek, Boulder County, CO. D₅₀ dashed line indicates the particle size at which 50% of all samples were equal to or less than.

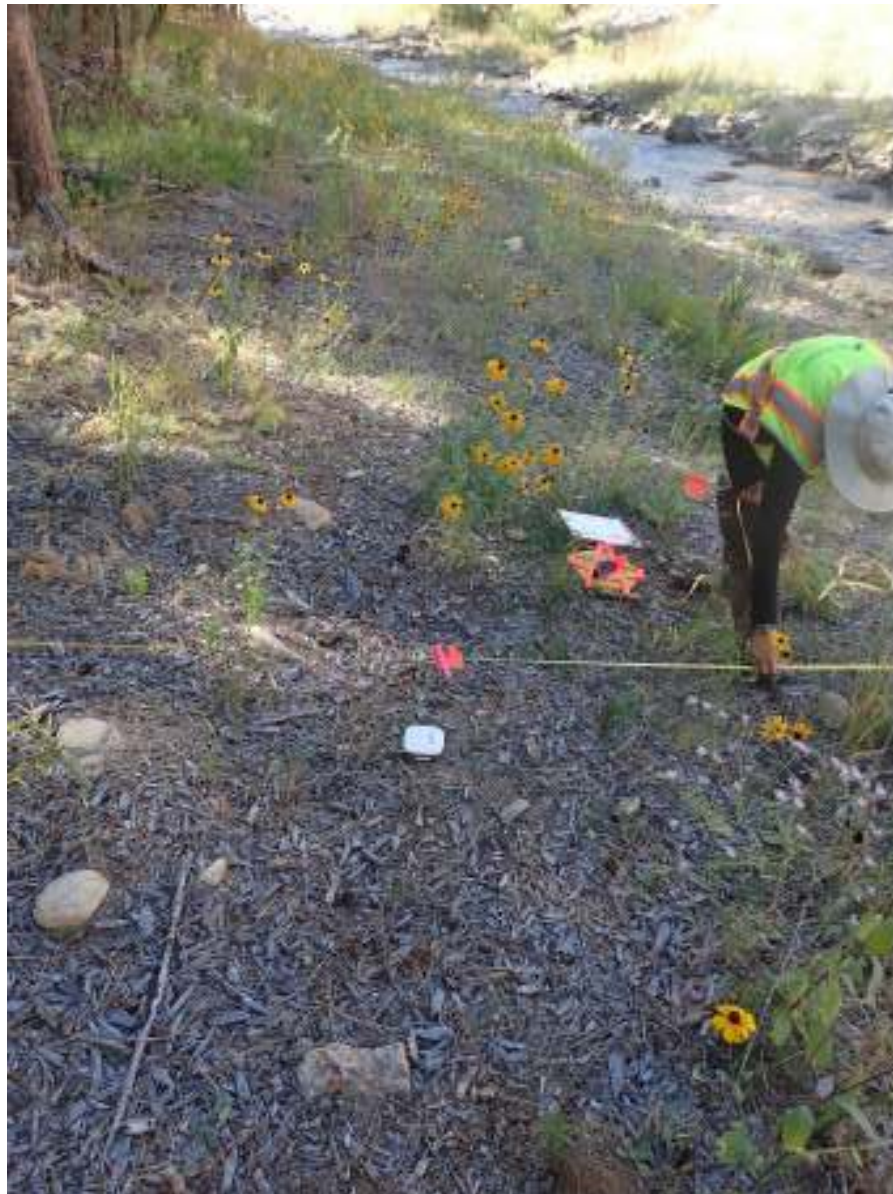
Although US Buckingham showed more native stem cover, the percent bare ground was high. LWOOG restoration project sites typically include a maintenance and monitoring warranty of revegetated sites that outlines stem cover thresholds for the first three years post-restoration. From these suggested thresholds, we expect greater than 30% stem cover one year after seeding. After one growing season, the US Buckingham site had 45% or less stem cover, with the majority of plots falling within this warranty. Bare ground at this site was primarily comprised of the wood chip mulch used during reseeding (Figure 7). In comparison, the bare ground at the Buckingham Site was comprised by stream cobble, bedrock, and thatch.

Figure 7. Image from 2018 vegetation survey at the Upstream Buckingham riffle site on Left Hand Creek, Boulder County, Colorado. This image was taken from the right bank, floodplain plot. Bare ground is occupied by woodchips.

3. Reseed floodplain, riparian, and creekside vegetation zones at Upstream Buckingham

Revegetated zones are comprised of high percent bare ground compared to other LWOG project warranty standards. However, it does not appear that weeds are outcompeting native species at the Upstream Buckingham location. We observed low levels of pioneer weed species including sweet clover and invasive thistles in reseeded areas at Upstream Buckingham. Although we expect to see succession in plant communities each growing season, the lack of non-native species at this specific location provides an excellent opportunity to strengthen the native plant community. Due to high percentages of bare ground, we suggest reseeding the floodplain, riparian, and creekside zones as early as spring 2019. By continued monitoring, there is an added benefit of quantifying revegetation with low presence of weeds.
